BALL BEARINGS DAMAGE

CASE HISTORY – CH 001

DC Motor – fan of oven refiner

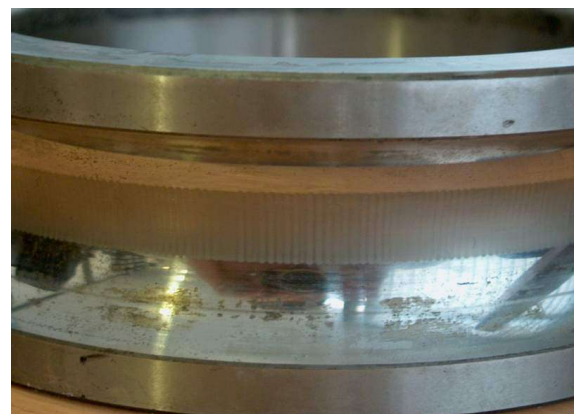
The presence of localized damage to the races of the bearings' drive-end side, due to current passing through the shaft. In particular, there were equidistant transversal striations present in the load zone of the outrace.

Damaged bearing
