MACHINE

Crushing machine – two stage gearbox

TECHNOLOGY USED

Vibration analysis

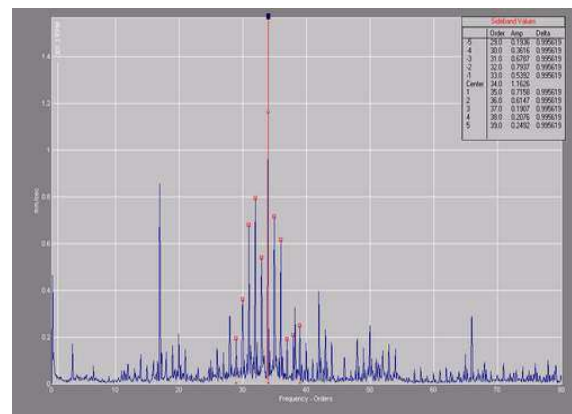
Vibrations spectra of gearbox

Analysis of the vibration spectra has shown localized damage to the pinion of the intermediate shaft. In addition, the characteristics of the spectra have shown misalignment between the intermediate shaft and the output shaft.

Serious

Overhaul the gearbox after a detailed inspection of the subcomponents (visual inspection of gears, inspection of the tolerances of the couplings and the gear alignment).

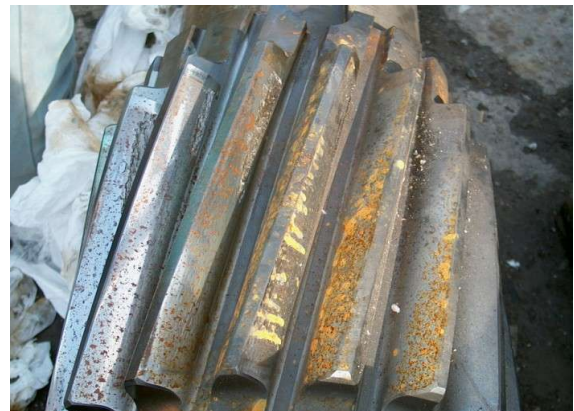
Damaged gear

Damage confirmed to the teeth of the pinion of the intermediate shaft because of incorrect gearmesh due to misalignment.

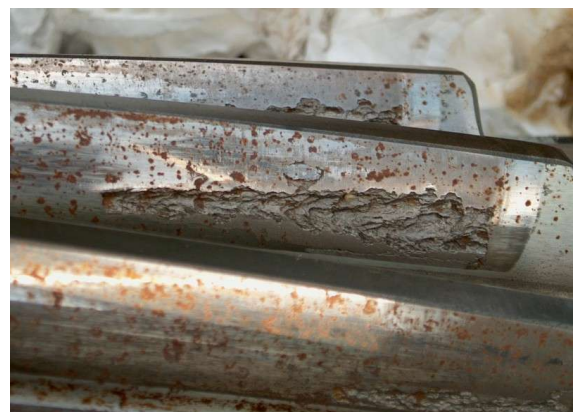
Damaged gear
