Glass and ceramics

Fuse on M7 motor

Infrared thermography

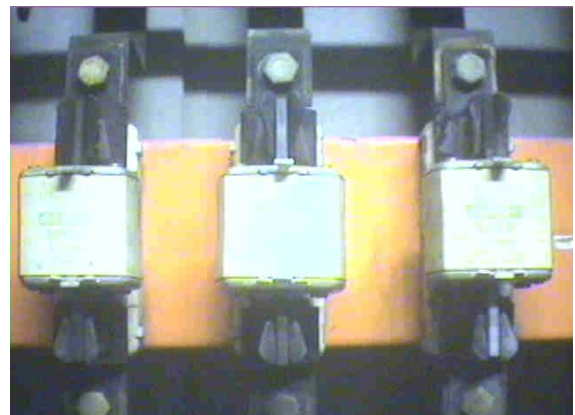
Three phases fuses image

In the course of the infrared thermography inspection made periodically according to the predictive maintenance plan, an abnormal temperature increase on the fuse on phase S was observed.

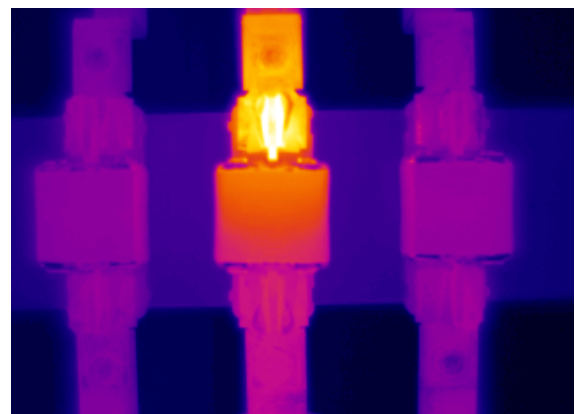
Infrared thermography had highlighted a temperature above the tolerance level on phase S. The cause of the temperature increase was traced to a loose-fitting fuse socket above phase S (maximum temperature was 120 °C).

Extreme

Infrared thermography image – abnormal temperature

Replace, as soon as possible, the fuse and the fuse socket.

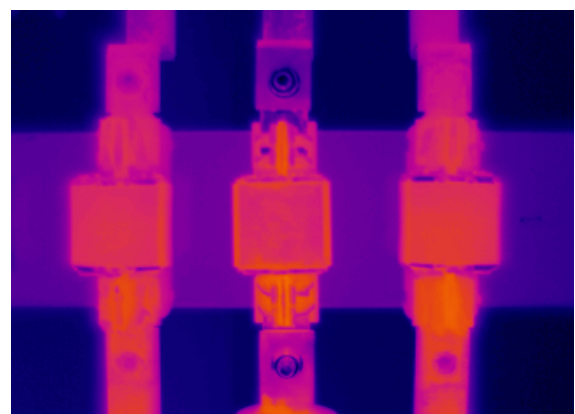
Following the replacement of the fuse socket, the maximum temperature observed had noticeably decreased, from 120 °C to 60 °C, confirming the diagnosis.

Infrared thermography image – following the replacement
