Synchronous generator – 47 MVA

PROBLEM ENCOUNTERED

Following electrical measurements taken during a partial overhaul, an anomaly in the measures of the shaft tension was discovered.

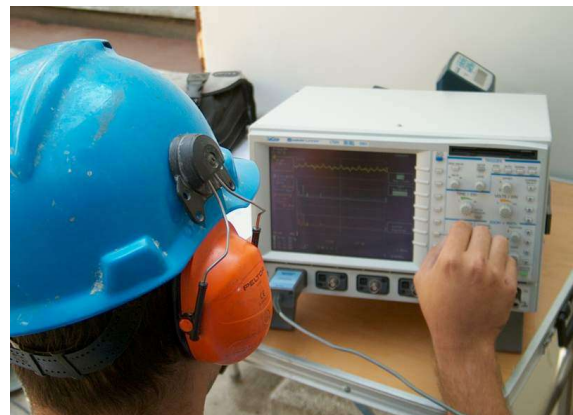
Measures of the shaft tension

A spectrum analysis of the shaft tension highlighted the presence of a sequence of regular harmonics which indicated a probable defect in the insulation between the coils of the winding of the rotor.

Serious

In order to confirm the abnormality found, the following advice was given: to measure the the dynamic impedance of the rotor and to perform static and dynamic reflectrametric tests on the rotor windings. Depending on tests results, to evaluate the possibility of replacing the alternator's rotor if necessary.

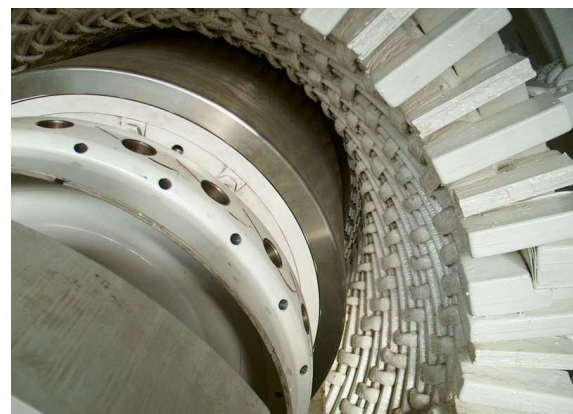
Generator

Subsequent test confirmed the presence of shorts in the rotor windings.
