Synchronous generator – 6,3 MVA

Electrical measurements / Visual inspection

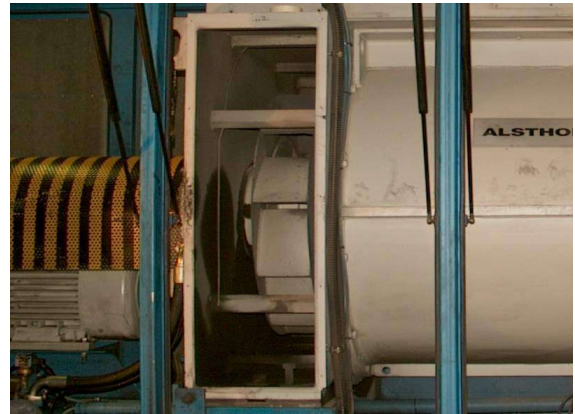
Generator

Following an inspection check done during a partial overhaul, a high level of contamination of the windings of the stator and the rotor was discovered. The value of the isolation resistance and of the polarization index (IDP) was notable but within the limits of conformity.

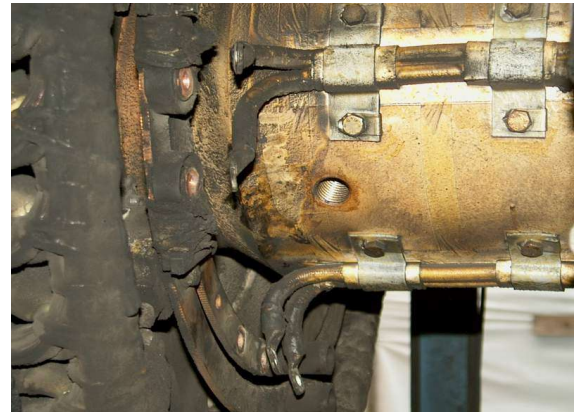
The modest value of the isolation resistance and of the polarization index (IDP) was probably caused by the raised level of contamination present on the windings.

Serious

Generator – stator and rotor windings contamination

To plan a procedure of cleaning the rotor and stator windings at the earliest programmed shut-down.

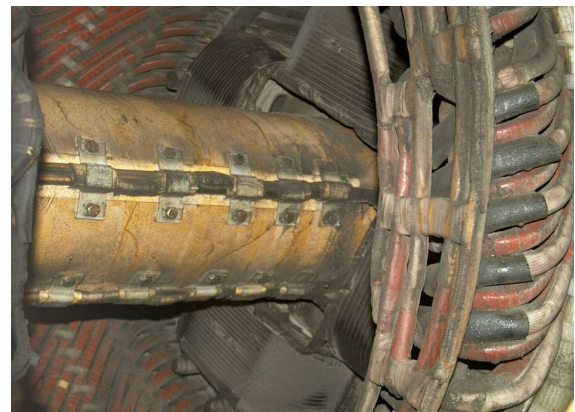
Generator – stator and rotor windings contamination

Subsequent tests on the alternator after the cleaning process, highlighted an improvement in the isolation resistance and the polarization index (IDP).
