Energy and gas

Synchronous generator – 47 MVA

Infrared thermography

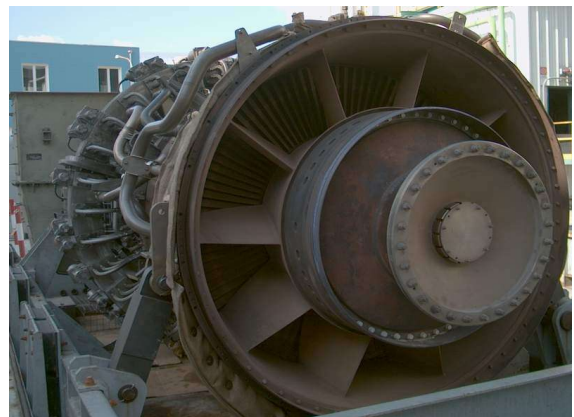
Turbine

A preventive infrared thermography inspection programmed before a shut-down revealed a rising temperature level on the flexible coupling which conveys the gas from the turbine to the boiler.

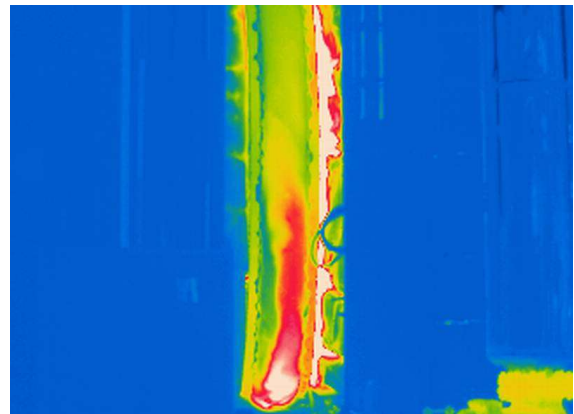
Analysis of the data highlighted a non-uniform temperature distribution on the surface of the flexible coupling.

Infrared thermography image – abnormal wear on the coupling

Serious

To inspect closely the coupling and evaluate the possibility of substituting it at the earliest programmed shutdown.

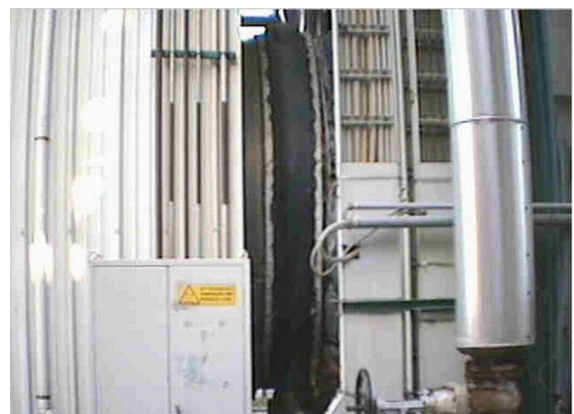
Turbine coupling

Subsequent test confirmed the presence of abnormal wear on the coupling.
