Synchronous generator – 47 MVA

PROBLEM ENCOUNTERED

Following electrical measurements taken during a partial overhaul, an anomaly in the measures of the shaft tension was discovered.

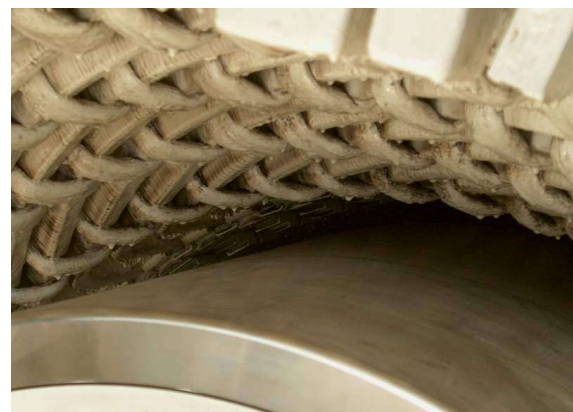
Generator

A spectrum analysis of the shaft tension highlighted the presence of a sequence of regular harmonics which indicated a probable defect in the insulation between the coils of the winding of the rotor.

Subsequent test confirmed the presence of shorts in the rotor windings.

In order to confirm the abnormality found, the following advice was given: to measure the the dynamic impedance of the rotor and to perform static and dynamic reflectrametric tests on the rotor windings. Depending on tests results, to evaluate the possibility of replacing the alternator's rotor if necessary.
